## **5. STRUCTURAL INTEGRITY**

### **5.1 STRUCTURAL STRENGTH AND DISTORTION TESTS - STRUCTURAL SHAKEDOWN TEST**

## **5.7 STRUCTURAL DURABILITY TEST**

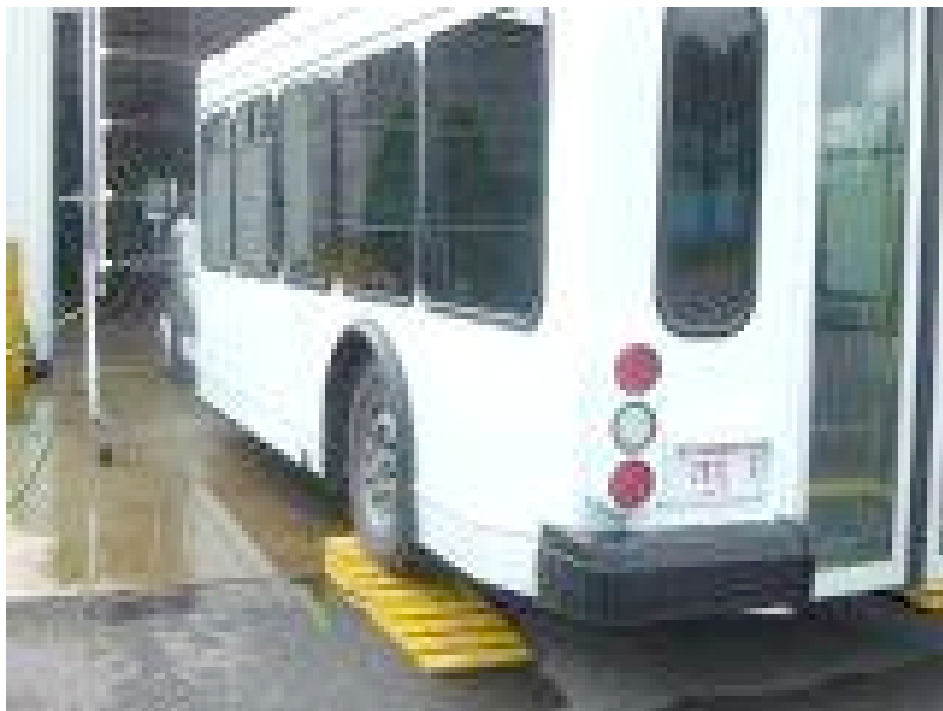
**RIGHT FRONT WHEEL SIX INCHES HIGHER**

All doors, windows, escape mechanisms, engine, steering and handicapped devices operated normally throughout the test. In two positions of the test, with the kneeling activated the handicap ramp did not contact the ground when deployed. The undercarriage and body indicated no deficiencies. No water leakage was observed during the test. The results of this test are indicated on the following data forms.

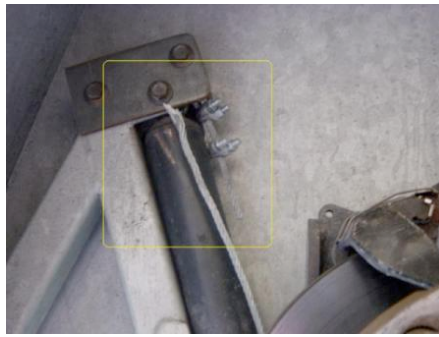
**BROKEN SUSPENSION TRAVEL  
(422 TEST MILES)**

**LIMIT CABLE**

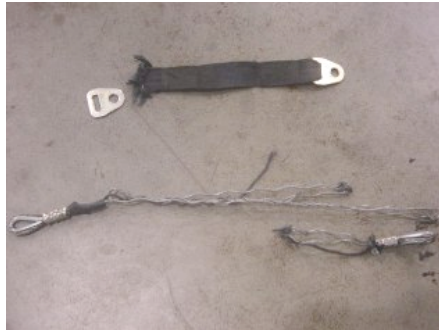
**BROKEN SUSPENSION TRAVEL  
(3,831 TEST MILES)**

**LIMIT CABLE**

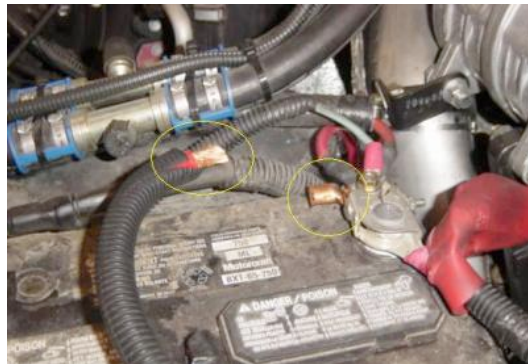
**BATTERY CABLE PULLED FROM  
(5,940 TEST MILES)**

**LUG**
