## **5. STRUCTURAL INTEGRITY**

### **5.1 STRUCTURAL STRENGTH AND DISTORTION TESTS - STRUCTURAL SHAKEDOWN TEST**

## **5.7 STRUCTURAL DURABILITY TEST**

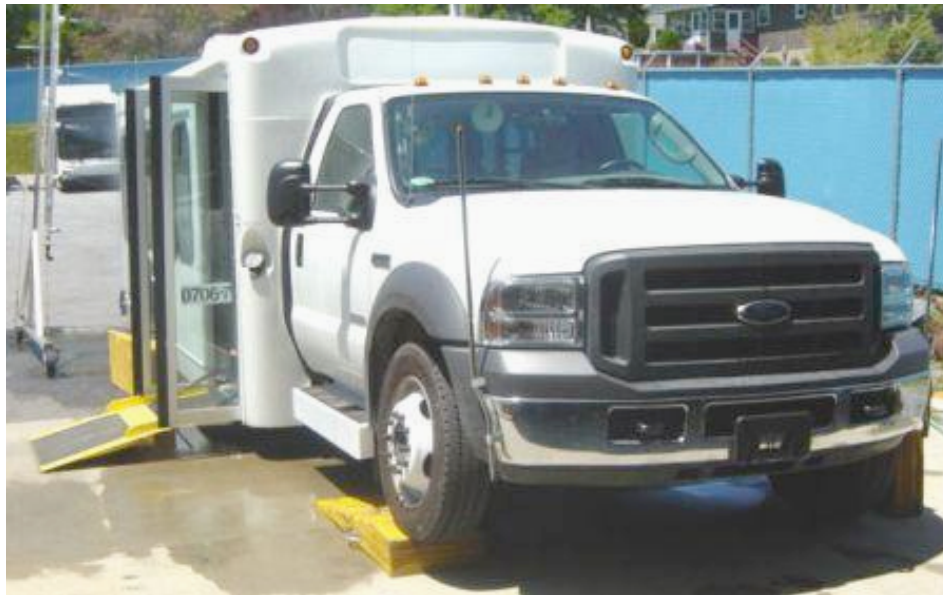
**RIGHT FRONT WHEEL SIX INCHES HIGHER**

All doors, windows, escape mechanisms, engine, steering and handicapped devices operated normally throughout the test. In two positions of the test, with the kneeling activated the handicap ramp did not contact the ground when deployed. The undercarriage and body indicated no deficiencies. No water leakage was observed during the test. The results of this test are indicated on the following data forms.

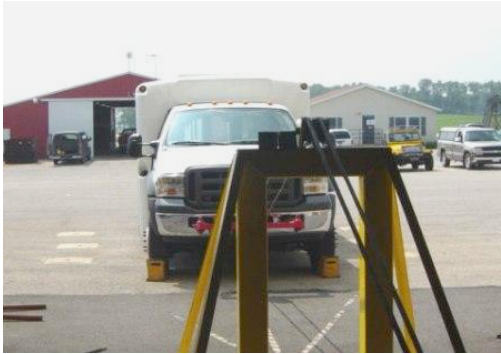
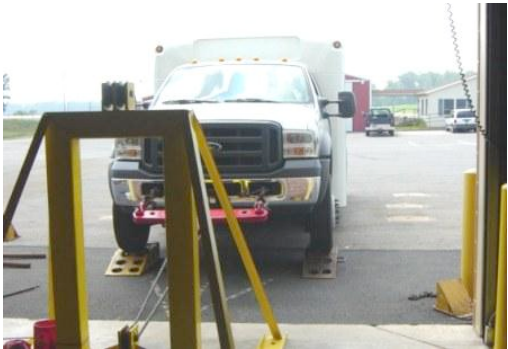
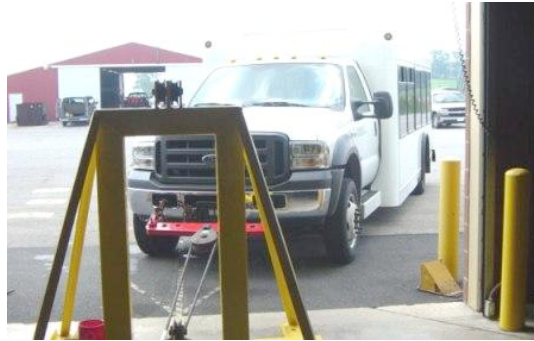
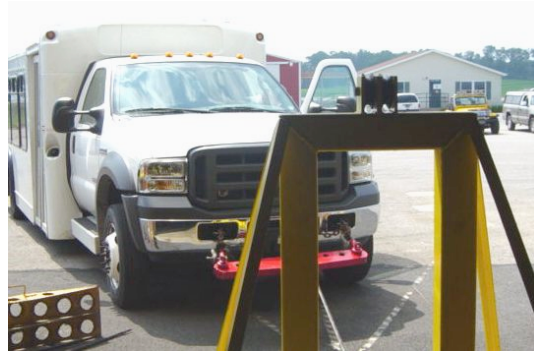
### 5.3 STATIC TOWING TEST

No damage or deformation was observed. The test bus was not equipped with rear
tow eyes or tow hooks, therefore, a rear test was not performed.

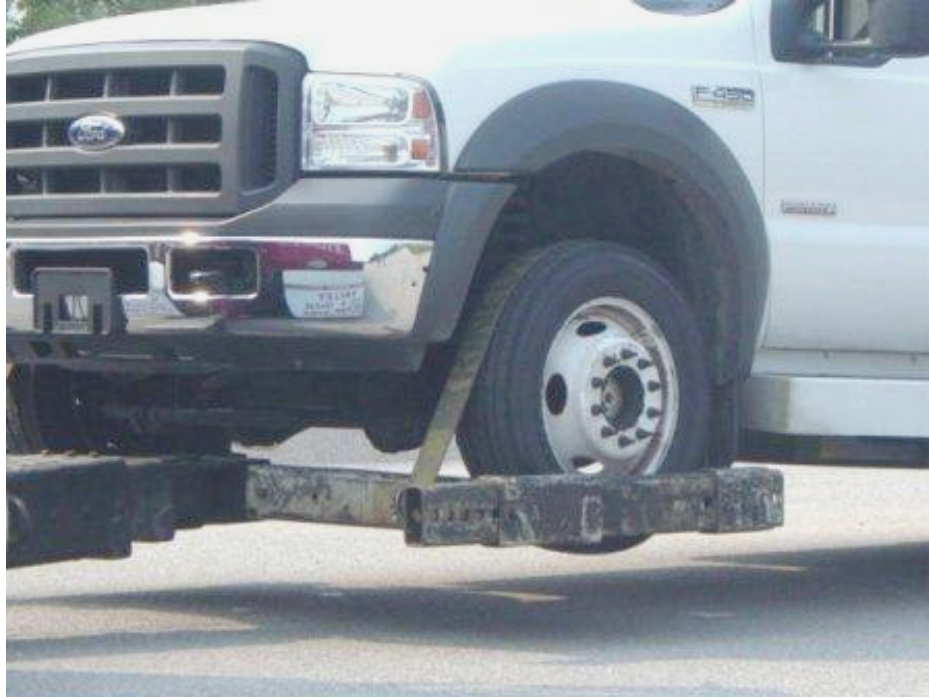
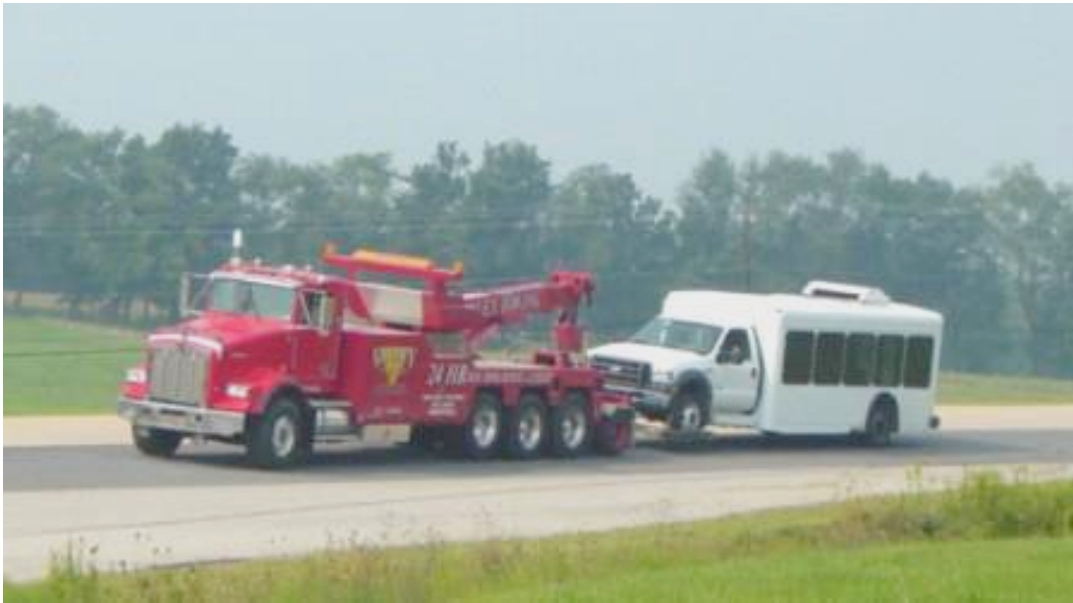
**TEST BUS IN TOW**

<b>Inspect tow equipment-bus interface.</b>
<b>Comments:</b> A safe and adequate connection was made between the tow equipment and the bus.
<b>Inspect tow equipment-wrecker interface.</b>
<b>Comments:</b> A safe and adequate connection was made between the tow equipment and the wrecker.
<b>Towing Comments:</b> A front lift tow was performed incorporating a hydraulic under lift wrecker.
<b>Description and location of any structural damage:</b> No damage or deformation was observed.
<b>General Comments:</b> No problems with the towing interface or tow were encountered during testing.
